NATIONAL PROGRAM FOR INSPECTION OF NON-FEDERAL DAMS
PALMER BROOK DAM MA 0 (U) CORPS OF ENGINEERS WALTHAM
MA NEW ENGLAND DIV MAR 81

4. TITLE (and Subtitle) Palmer Brook Dam NATIONAL PROGRAM FOR INSPECTION OF NON-FEDERAL DAMS		5. TYPE OF REPORT & PERIOD COVERED INSPECTION REPORT
7. AUTHOR(s) U.S. ARMY CORPS OF ENGINEERS NEW ENGLAND DIVISION		6. PERFORMING ORG. REPORT NUMBER

Palmer Brook Dam

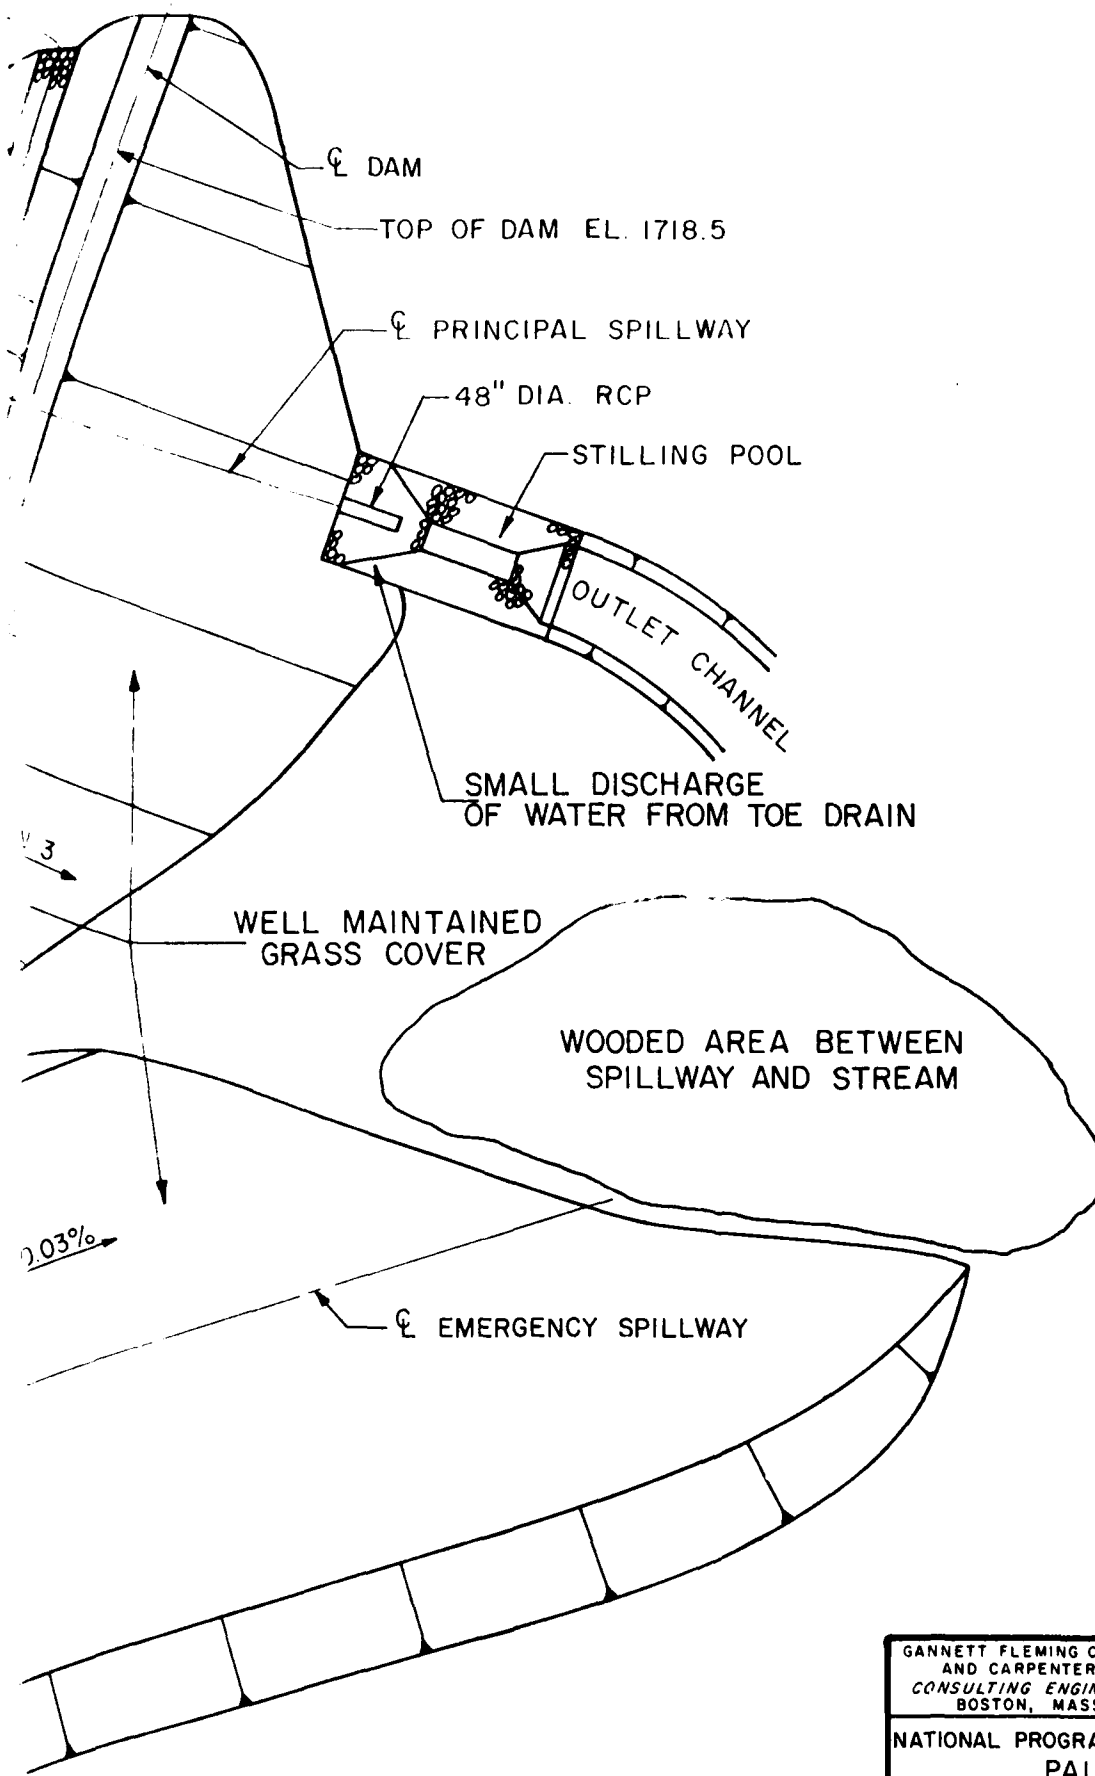
GANNETT FLEMING CORDRY AND CARPENTER, INC. CONSULTING ENGINEERS BOSTON, MASS.		U. S. ARMY ENGINEER DIVISION NEW ENGLAND CORPS OF ENGINEERS WALTHAM, MASS.	
NATIONAL PROGRAM OF INSPECTION OF NON-FED DAMS PALMER BROOK DAM EXHIBIT B-1-DAM			
RESULTS OF VISUAL INSPECTION			
DRAWN	CHECKED	APPROVED	SCALE: 1 IN. = 50 FT.
L.L.R.	D.B.W.	F.J.K.	DATE: 2/81 PAGE B-7

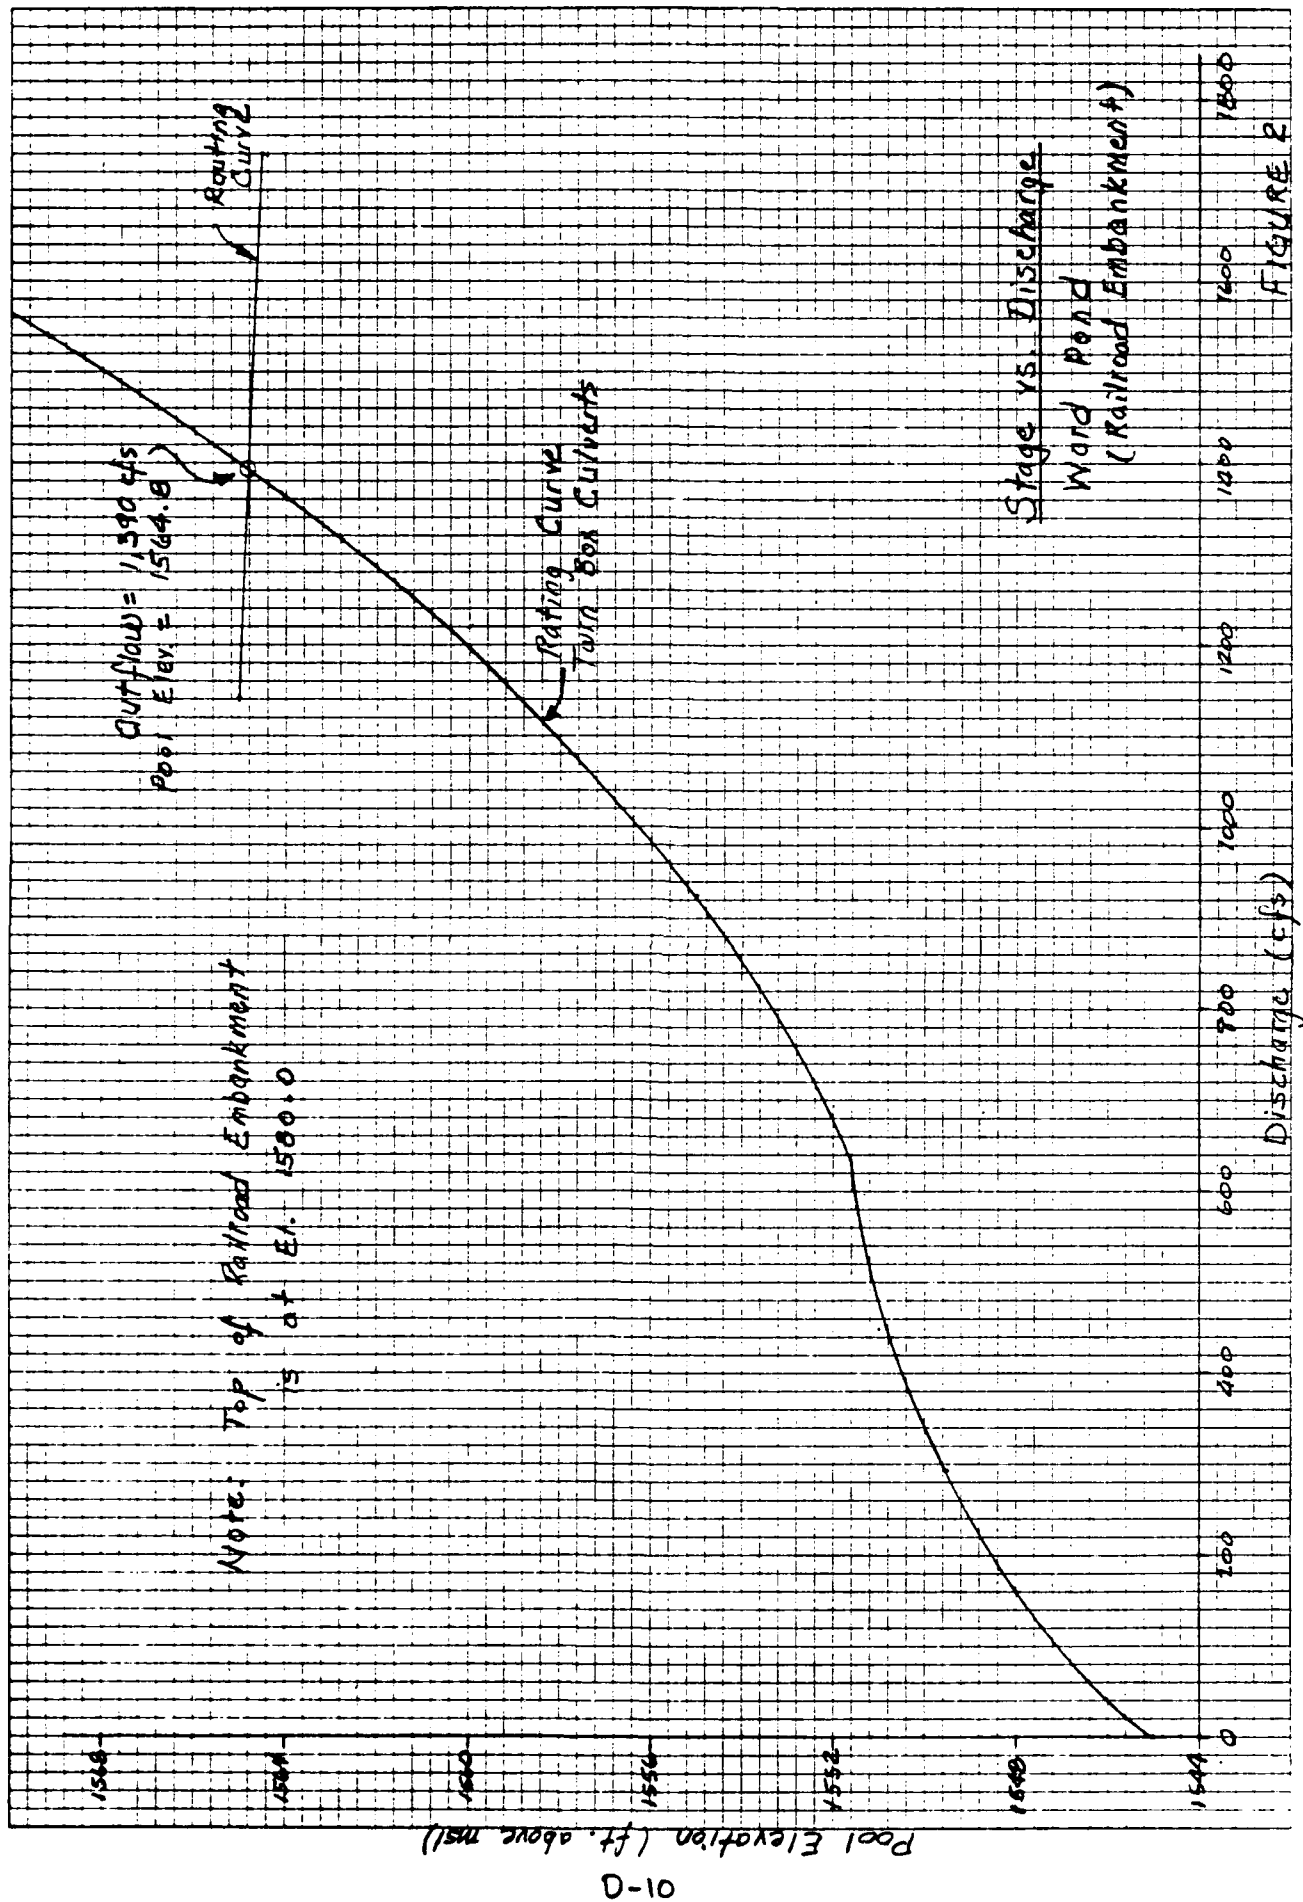
FIGURE 2

Routing Curve for Ward Pond

Rating and routing curves are plotted on Figure 2 (next sheet). From Figure 2, the results are:

The results presented above are for failure of Palmer Brook Dam. The normal procedure to evaluate pre-failure levels is not applicable because the steady state pre-failure discharge of 1,860 cfs is larger than the routed failure outflow of 1,390 cfs. An accurate evaluation of pre-failure stages would require a complete routing computation similar to the one for dam failures. An approximation of the pre-failure stage in Ward Pond can be determined from the PMF volume and by assuming no outflow from the railroad culvert. The total PMF volume entering Palmer Brook reservoir is 1,560.5 ✓ acre-ft (19 inches of runoff over 1.54 mi²). Since it was assumed that the pool was initially at the principal spillway crest, but that the principal spillway would become clogged, there would be some water "permanently" stored between the principal spillway crest and the auxiliary spillway crest.

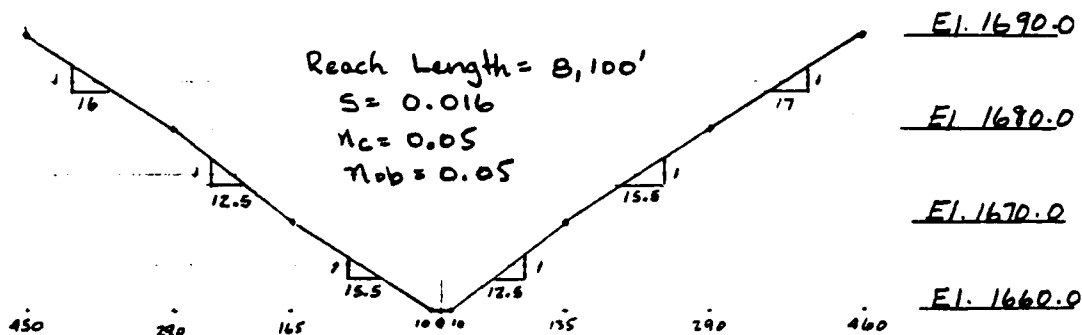
Stream Section 1

Rating Curve - Section 1

Pre-failure stage in Reach 1:

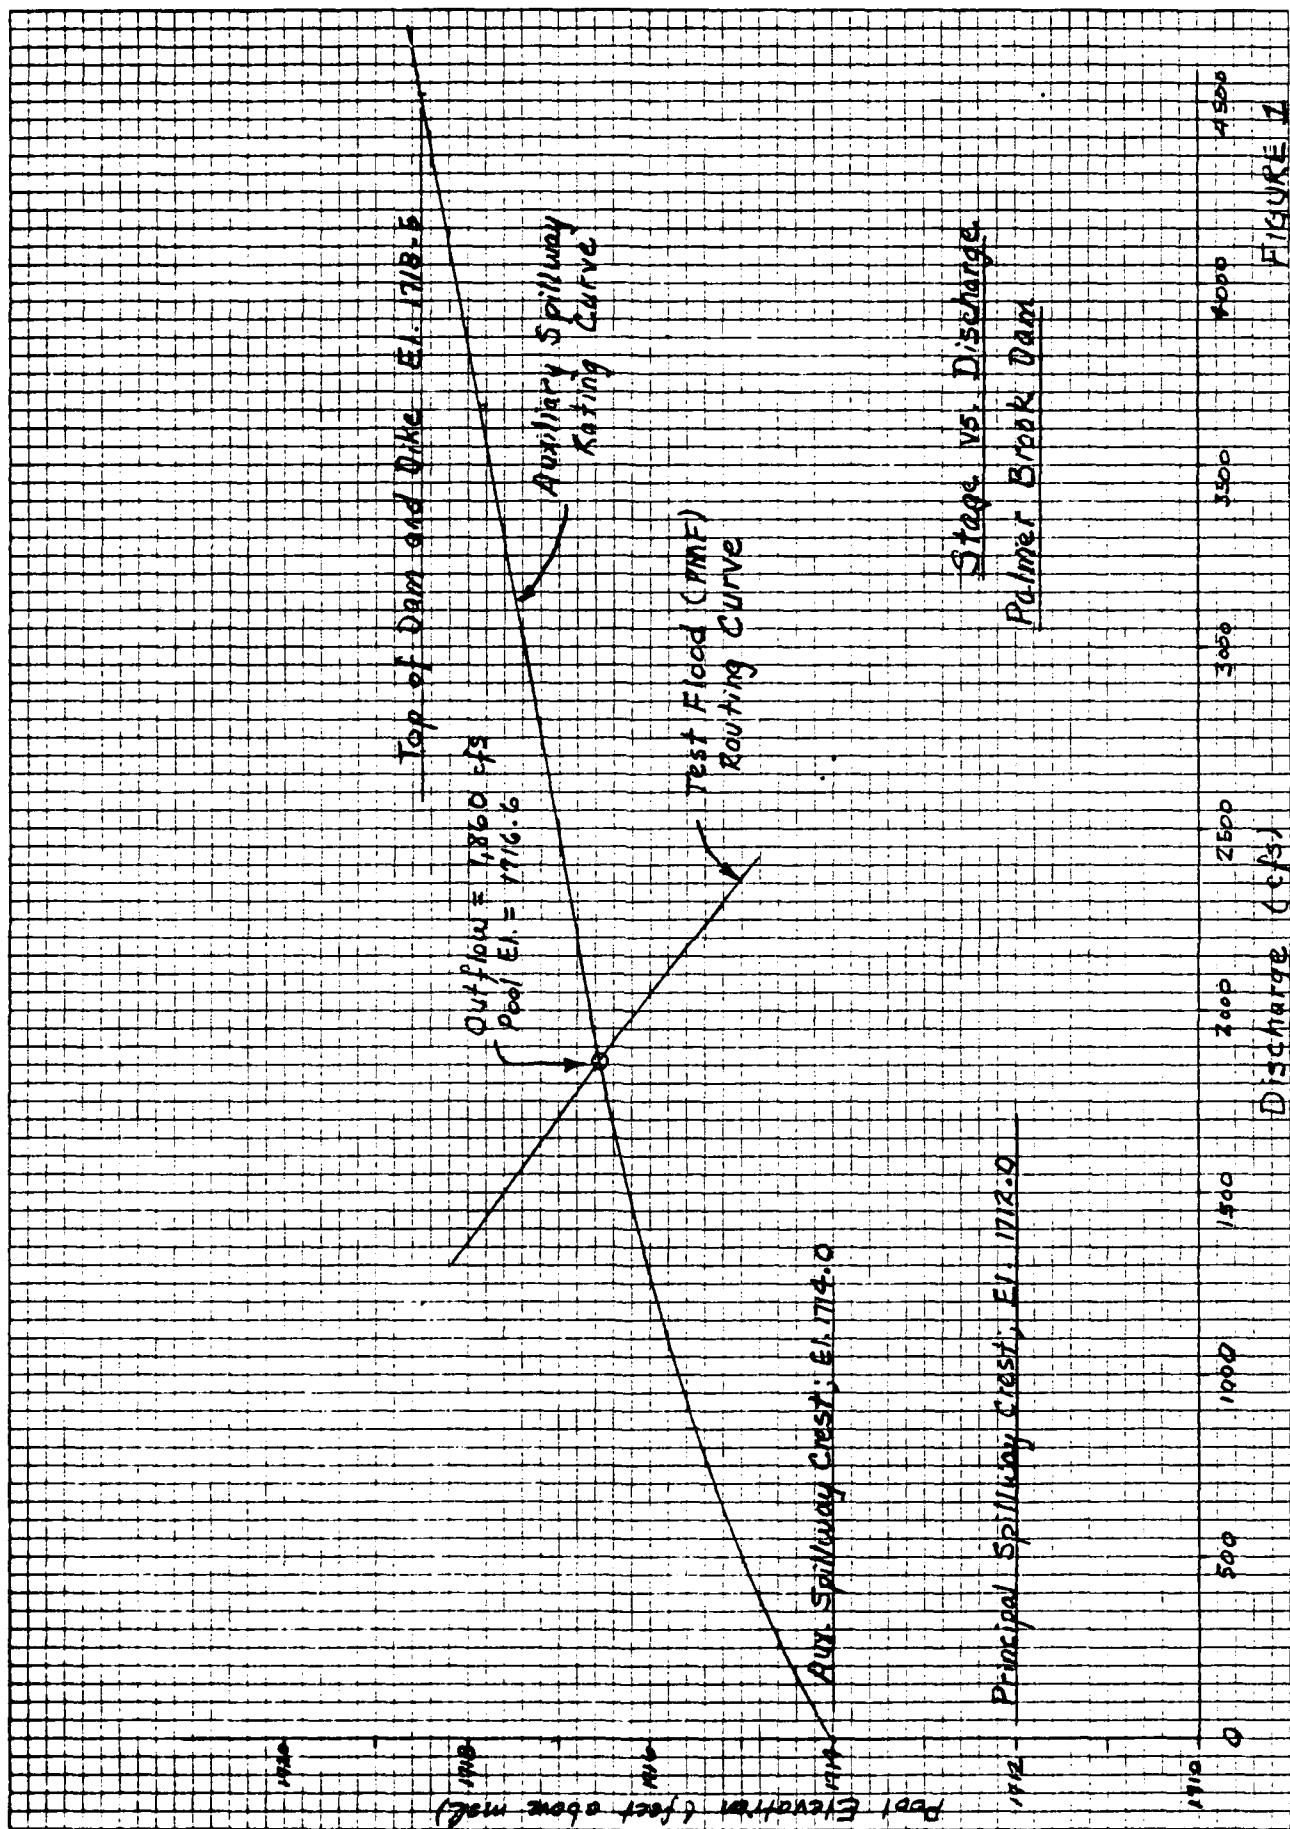
FIGURE 1

From Results Shown on Figure 1 (next sheet):

For the size (intermediate) and hazard classification (high hazard) of Palmer Brook Dam, the recommended test flood is the PMF.

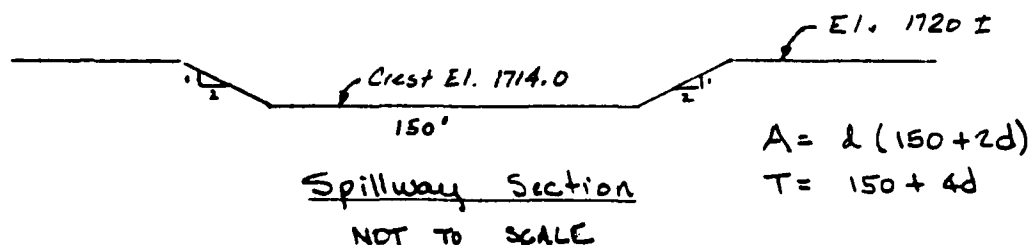
Auxiliary Spillway Rating Curve

Auxiliary spillway is a trapezoidal channel with a 2% adverse slope in the approach area and a 3% slope in the exit area. A critical depth analysis will be used, and approach losses will be neglected.

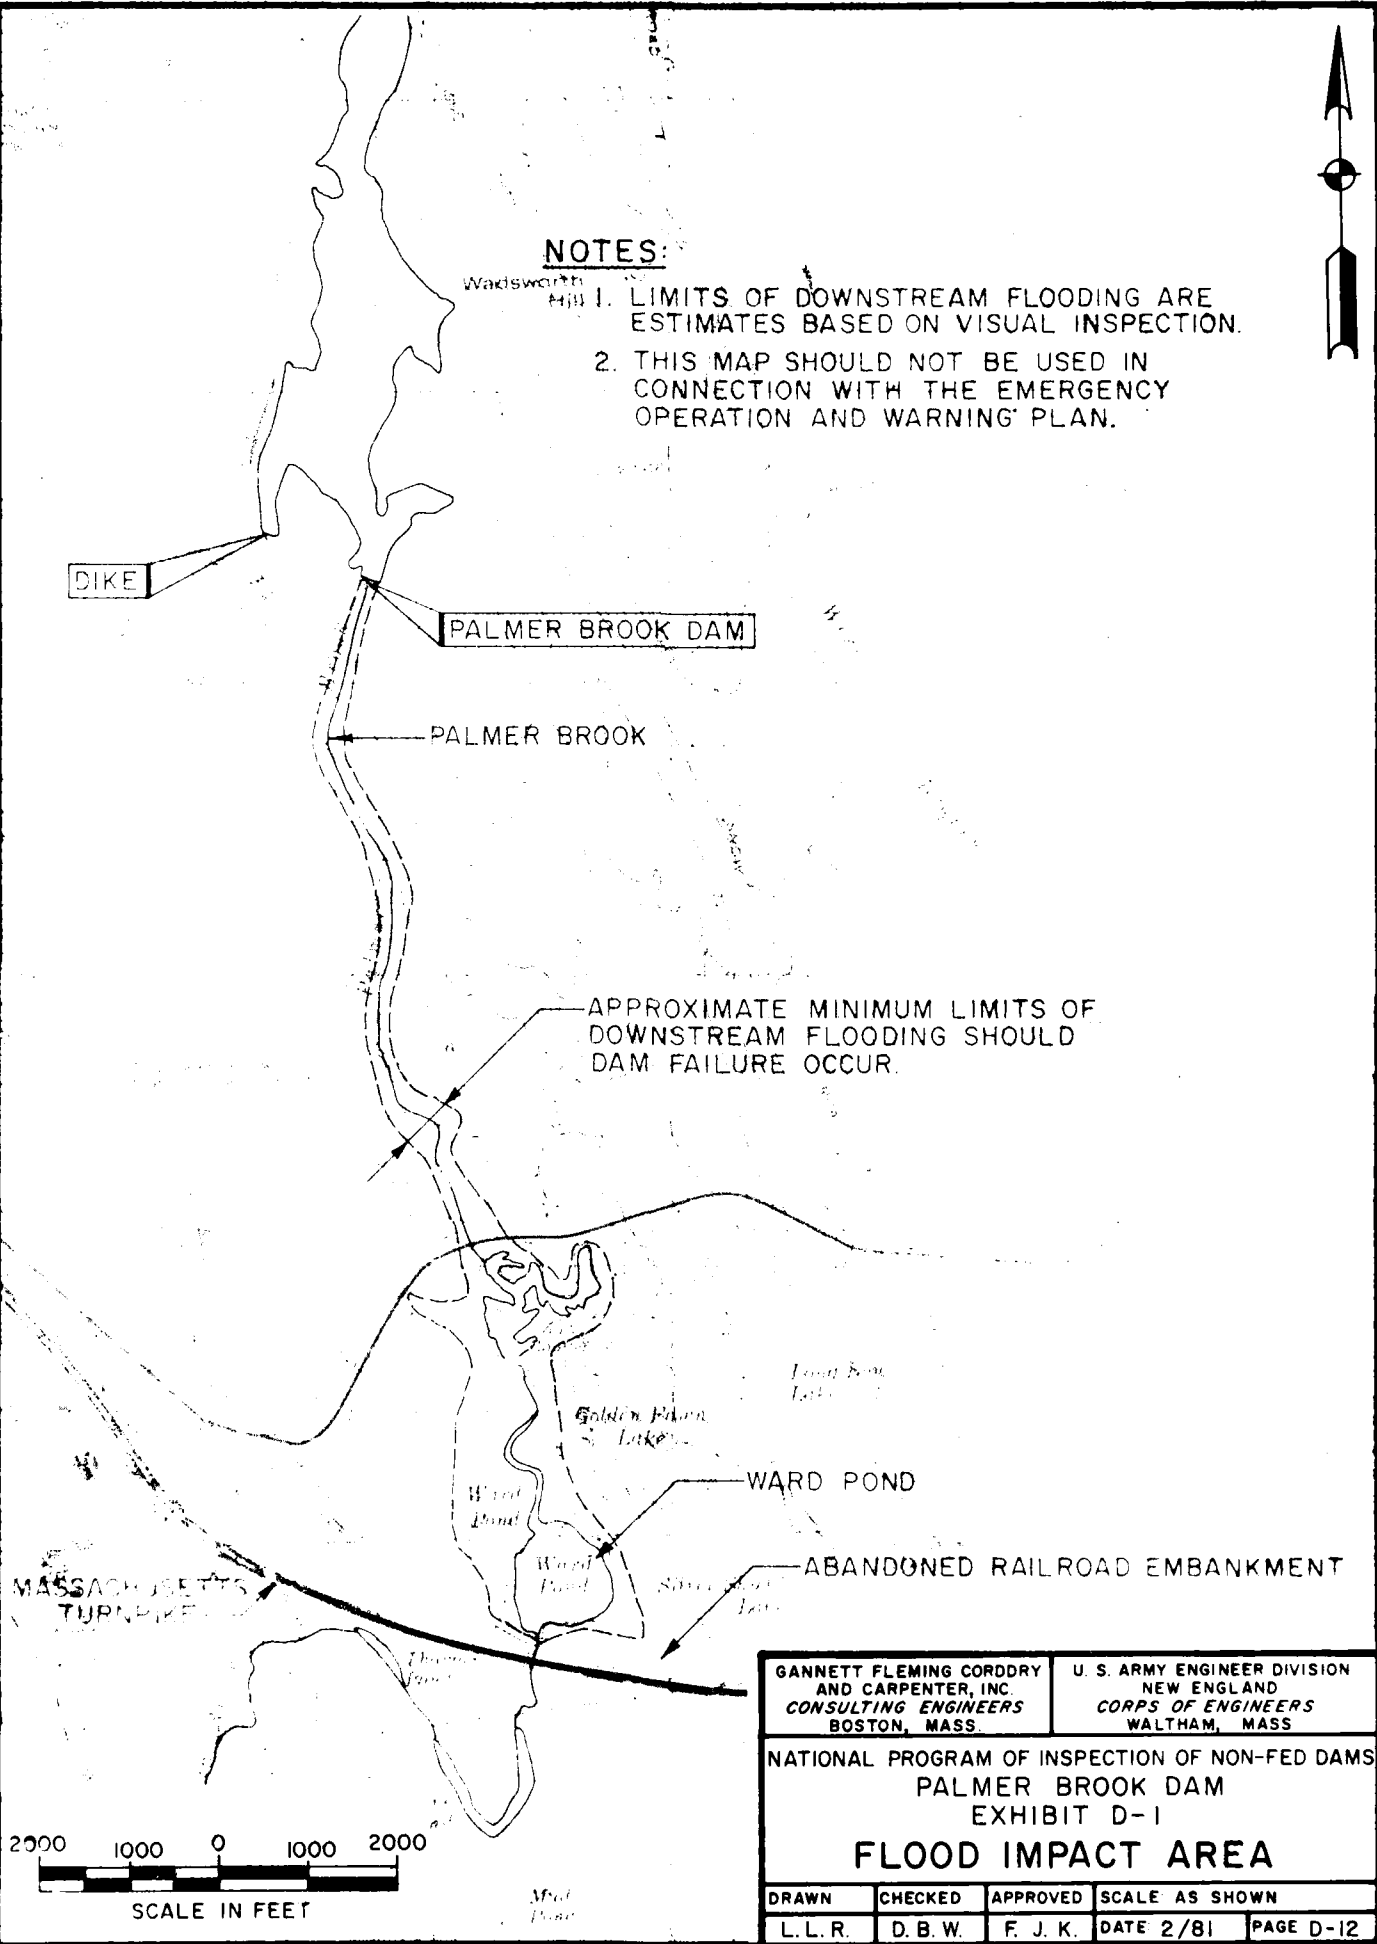
1. LIMITS OF DOWNSTREAM FLOODING ARE ESTIMATES BASED ON VISUAL INSPECTION.
2. THIS MAP SHOULD NOT BE USED IN CONNECTION WITH THE EMERGENCY OPERATION AND WARNING PLAN.
